# Hypervelocity Impact Testing of Space Station Freedom Solar Cells

March 1994

(NASA-TM-106509) HYPERVELOCITY  
IMPACT TESTING OF SPACE STATION  
FREEDOM SOLAR CELLS (NASA. Lewis  
Research Center) 10 p

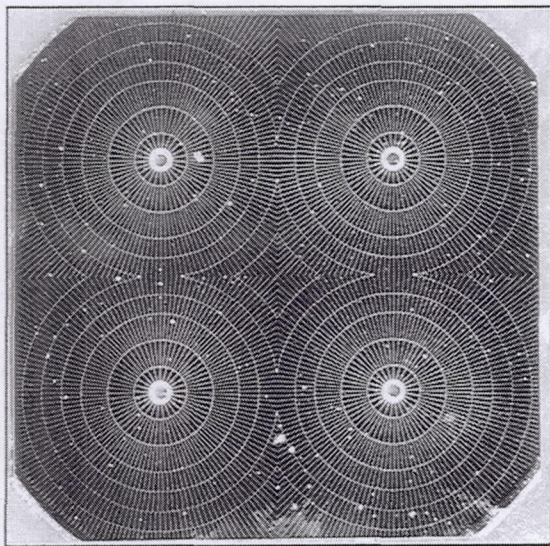
The front surface of the solar cells were shot with 100 and 400 micron aluminum oxide and 100 micron olivine particles. The typical impact features on the 8cm X 8cm cells are shown in Figure 1. Most of the features are less than 1000 mm across but a few are in 1000 to 2000 mm range.

Figure 1, Impact Features on Cell 11-221

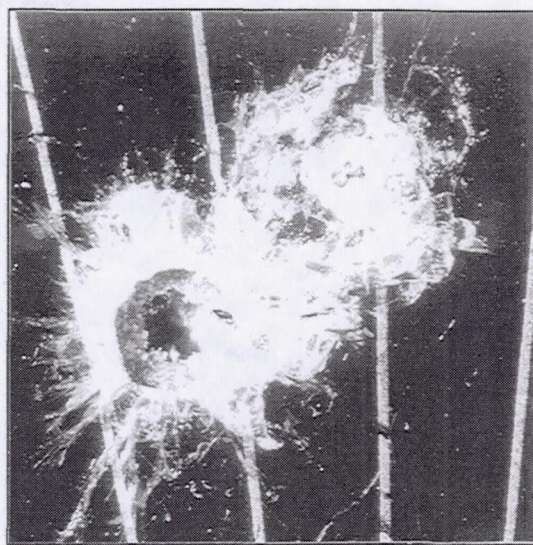
One of the larger features on cell 11-221 is shown in Figure 2. The well defined crater to the upper left of center is about 300 microns across. This crater was formed by a particle with a velocity of 5.4 km/s. The morphology of this crater is nearly identical to one reported by E. Schneider for a particle with identical velocity. [2] The spall to the lower right of center of Figure 2 was caused by a second particle impact.

Figure 2, Large Impact Feature on Cell 11-221

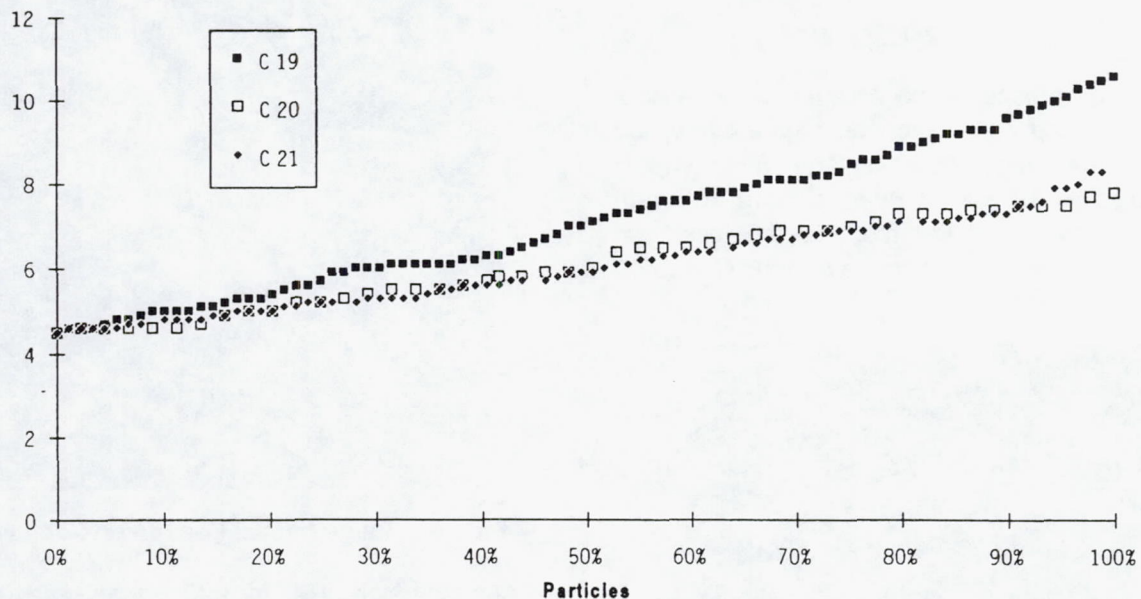
Approximately 150 to 200 impact sites were recorded for each cell. Velocities were obtained for about one quarter to one half of the sites. A plot of typical velocities is shown in Figure 3.

The plot shows that velocities generally ranged from 5 to 10km/s. The average velocity for shot C19 was 7.2km/s. Shots C20 and C21 had average velocities of 6.1km/s and 6.0km/s, respectively.

There were a few impacts caused by particles with velocities between 10 and 11km/s. Examination of these sites revealed small clusters of impacts. The respective film penetration were single holes with diameters two or three times larger than the crater diameters. This seems to indicate that the particles with velocities above 8 or 10km/s are fracturing when they pass through the Mylar film.

Figure 3, Particle Velocities

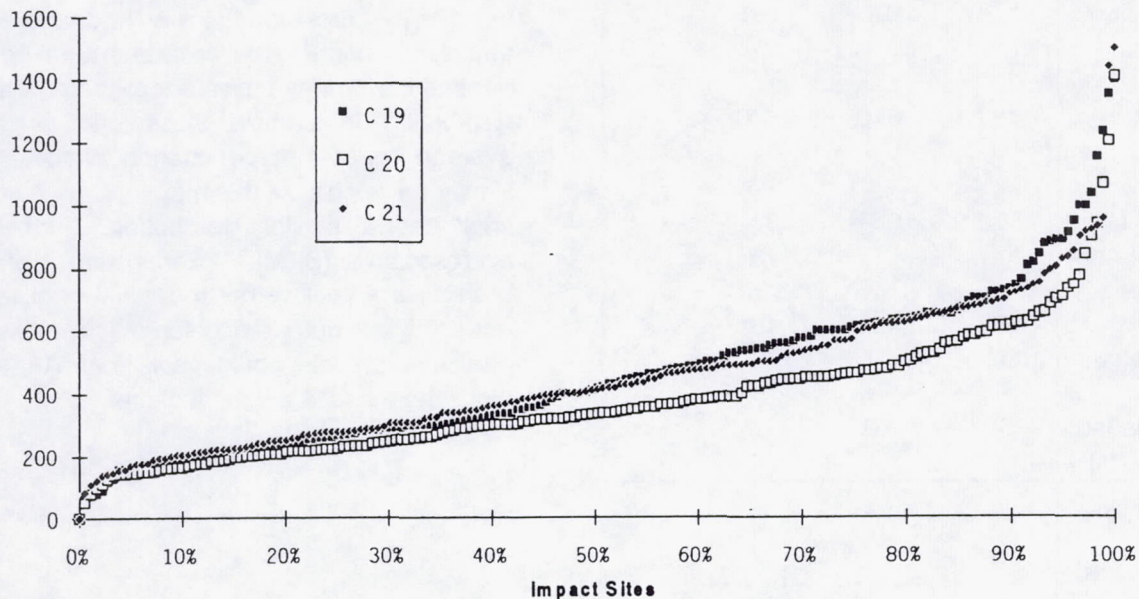
To determine the relative damage done to the solar cell, the diameter of the fractured zone surrounding the impact site was measured. These are plotted in Figure 4. The examination of shot C19 shows that most fractured zones are between 200 microns and 700 microns in diameter, the average being 460 microns. The average fractured zone diameter for shots C20 and C21 was 370 microns and 440 microns. The largest fractured zones, i.e. greater than 1000 microns across, often proved to be caused by multiple impacts. The areas of the fractured zones were calculated and summed. Comparing this sum with the total cell surface area indicated that the total fractured area was only .61% for shot C19, .50% for C20, and .57% for C21.

Figure 4, Fractured Zone Diameters

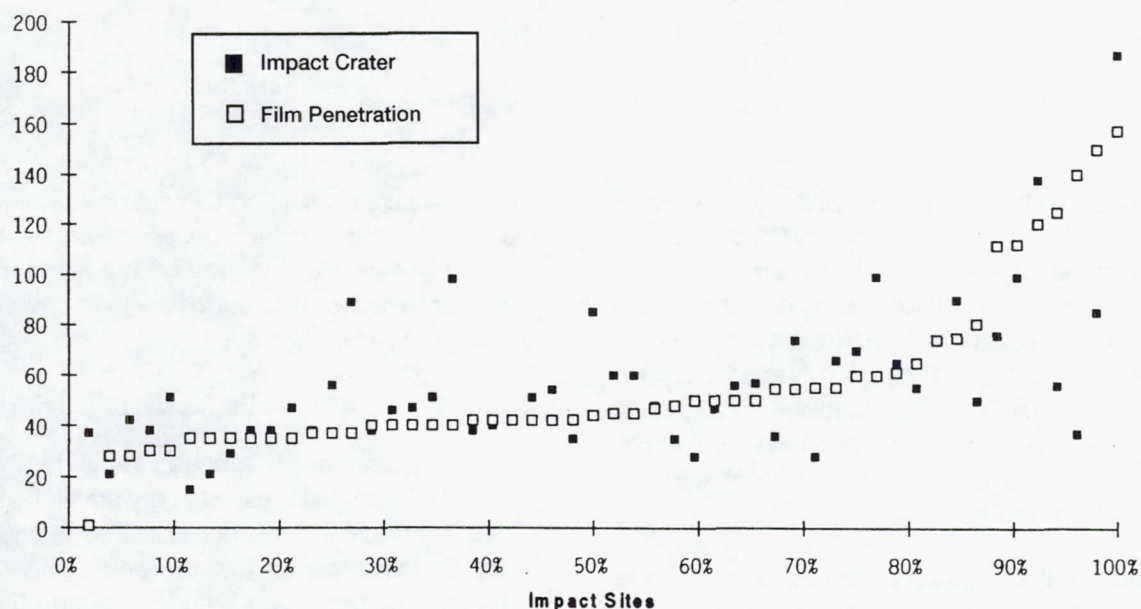
Where discernable, the diameters of the impact craters were measured along with the penetration hole in the Mylar film. The measurements for shot C19 are shown in Figure 5. The plot shows some correlation between sizes of the impact crater and the film penetration. It also shows that the two are approximately the same size. The average crater diameters for shots C19, C20, and C21 were respectively 51, 56, and 83 microns. The average penetration diameter in the Mylar film were respectively 58, 45, and 48 microns.

Figure 5, Impact Crater and Film Penetration Diameters

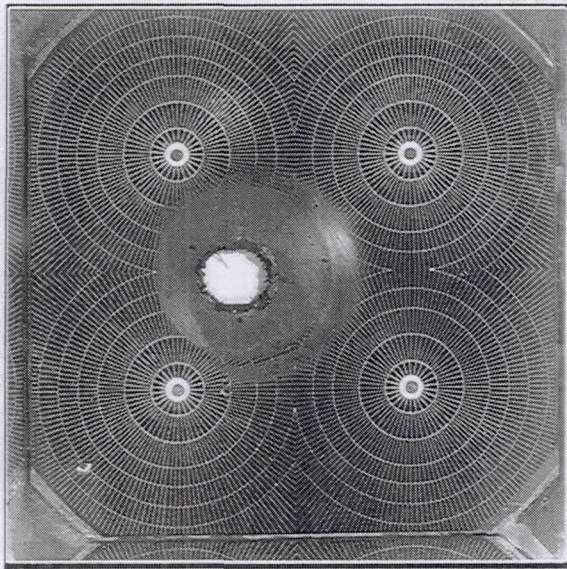
At MSFC the impact produced a neat hole approximately 3/8" in diameter as shown in Figure 6. The area of the hole is approximately 0.129 in.<sup>2</sup> which represents only 1.3% of the total cell area. Although there were a few cracks in the cover glass of the adjacent cells, the propagated damage was minor. The obscured area surrounding the impact hole is contamination deposited during the firing of the

gun. The contamination film was assumed to be a residue of melted Lexan<sup>3</sup>. Most of this contamination was cleaned off but a transparent film remained on the surface which covered an area about 1" in diameter.

Figure 6, Impact Feature from 1/4" Projectile

The 1/4" projectile created a penetration 3/8" in diameter which is only 1.7% of the total cell area but this caused a 35% reduction in maximum power output of the individual cell. Although I<sub>max</sub> of the cell dropped 29% the I<sub>max</sub> of the coupon only dropped 20%, which resulted in a 17% decrease in power output of the array. This indicates that summing the current losses from individual cells does not equal the total current loss in an array.
